Application Note AN-2016-1

1553B Data Bus Cable Fault Detection Through Multiple Transformer Couplings

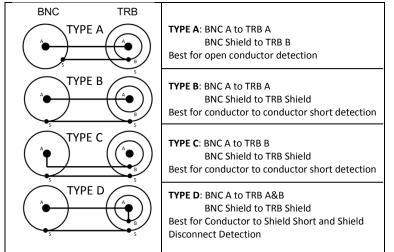
Figure 1 – MOHR TRB Triaxial Adapter Kit Schematics (P/N CTA20100)

The MOHR TRB Triaxial Adapter Kit allows for connections to the shield and individual conductors in 1553 data cables, aiding in the identification and location of multiple fault types on 1553 data bus Lines. In addition to the TRB adapters, multiple gender changers and terminations are provided in the kit. Figure 1 shows the four types of BNC to TRB adapters and their internal connections.

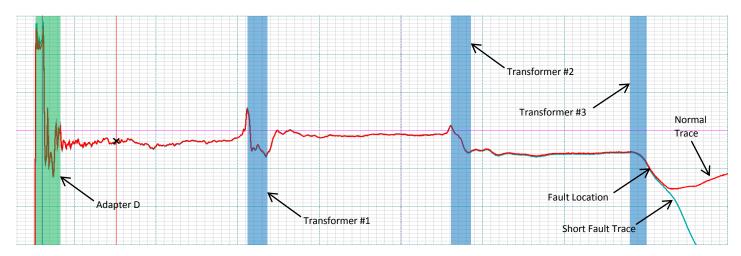
Figure 4 – Conductor shorted to shield fault detection through three transformer couplings using adapter D

A second use case shows the ability to detect a short between one conductor and the cable shield at a location beyond three transformers using adapter type D. Figure 4 shows the location of each of the three transformers as blue shaded bands. A short between the shield and conductor is initiated at a location 24 inches beyond the third transformer as shown by the blue trace. The normal (non-shorted) trace is shown in red. The fault is detectable as a sharp decrease in impedance at the fault location.

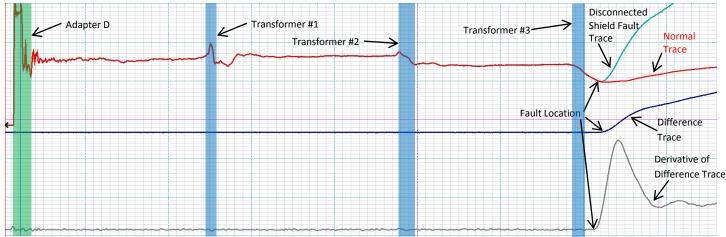
Figure 5 – Disconnected shield fault through three transformers with difference trace and derivative of difference trace for fault location

A third use case shows the ability to detect a disconnected shield on the main 1553 data bus cable at a location 24 inches beyond the third transformer in a three transformer bus line using adapter type D to detect the fault as shown in Figure 5 below. Each transformer is clearly located as shown with the blue shaded bands. The trace with the disconnected shield is shown in blue, with the normal trace shown in red in the top traces of figure 5. The disconnected shield fault is easily detected as a sharp increase in impedance at the far end of the cable.

There is a level of familiarity and experience involved in discerning faults if a prior (normal) trace is not available for comparison. If a normal trace is available, the detection of faults becomes a routine operation of capturing data using the same parameters as the original (normal) trace scan, then using either on-board trace difference within the CT100, or using the external CTViewer PC-based software provided with each CT100 to compare the traces. Using either method, a difference trace can be generated, clearly highlighting the conductor fault as shown in figure 5.

When a difference trace is noisy or does not show as clear of a detection threshold as presented in figure 7, a derivative plot of the difference trace can yield clearer results as shown in Figure 5 with the grey trace.
